IDENTIFYING OPTIMUM PARAMETERS OF HOT EXTRUSIONS

Contract NAS 7-276

Progress Report No. 9
1 May 1966 to 15 July 1966

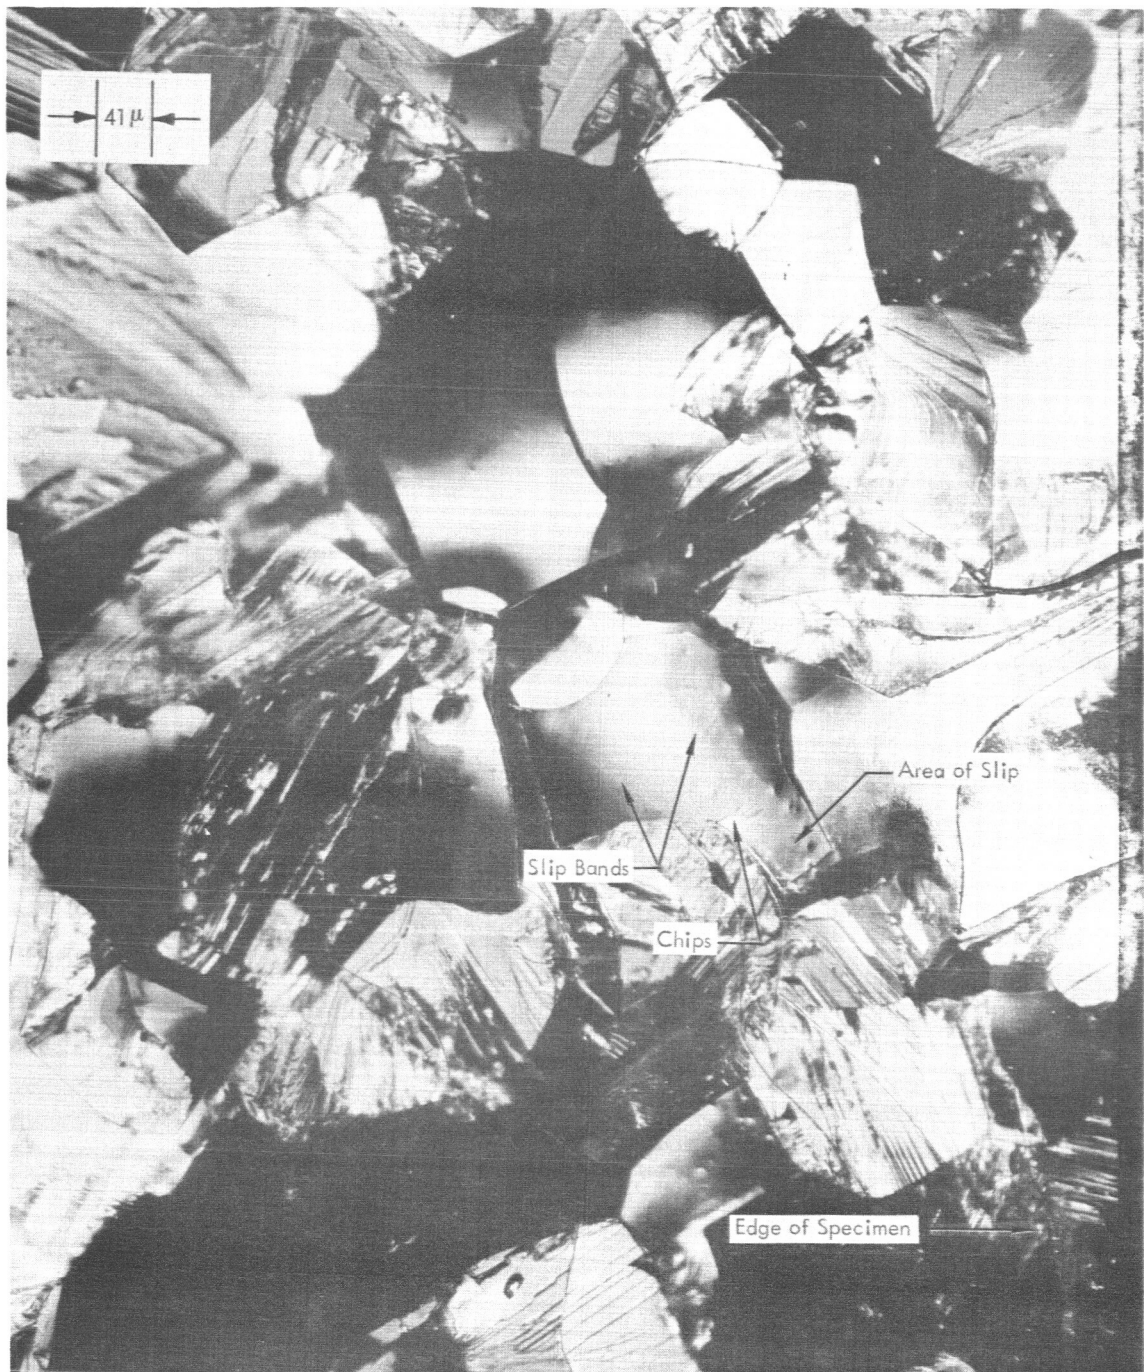
Further fracture analysis of extruded specimens is continuing. Figure 1 is a composite photograph of a complex fracture originating from one (or more) grain boundary surfaces approximately parallel to the fracture surface (Type I fracture). Of particular interest is the grain boundary surface nearest the specimen tensile surface which has faint off-sets highly suggestive of slip bands, apparent chipping and several close slip bands. This is rather suggestive of the mechanism of edge band fracture in bi-crystals shown by Stokes and Li⁽¹⁾.

FIGURE 1 - FRACTURE ORIGIN AREA OF SPECIMEN M-f-5 1-1

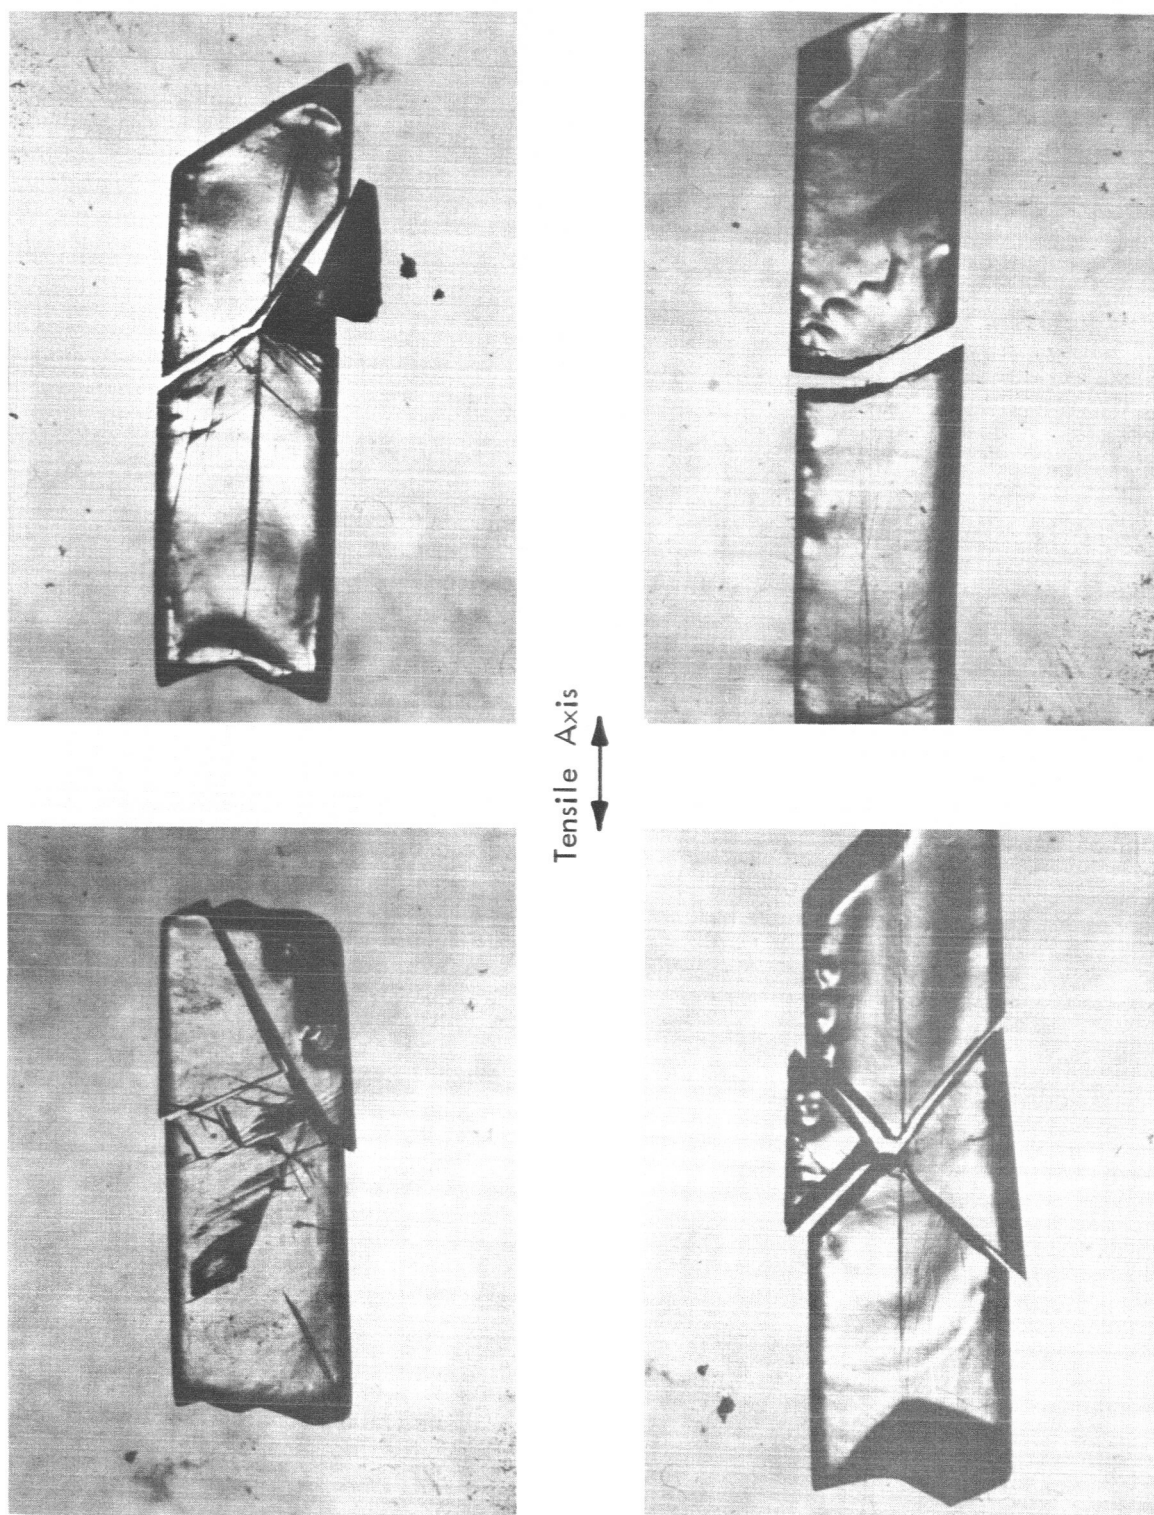
Therefore, some cursory room temperature bi-crystal flexure tests with the bi-crystal boundaries parallel to the tensile axis were made. Specimens were annealed at 3600°F(2035°C), chemically polished, then tested. These all failed by cleavage as expected, even when the cleavage angle to the tensile axis was high (see Figures 2-4). Figure 3 shows the tensile surface of a bi-crystal (Mb-3-1) which more nearly approached the conditions surrounding longitudinal boundaries in extruded MgO. This shows that both edge and screw bands were stopped at the boundary. Examination of the fracture surface (Figure 4) suggests an interior origin with several screw bands near the area of probable origin. However, it is also possible that fracture started at the boundary on the surface from either of the stopped screw or edge bands there, then propagated down the boundary a distance before branching out by cleavage into the two grains.

FIGURE 2 - FAILURE OF MgO Bi-CRYSTALS OF VARIOUS ORIENTATION WITH THE BOUNDARY PARALLEL TO THE TENSILE AXIS

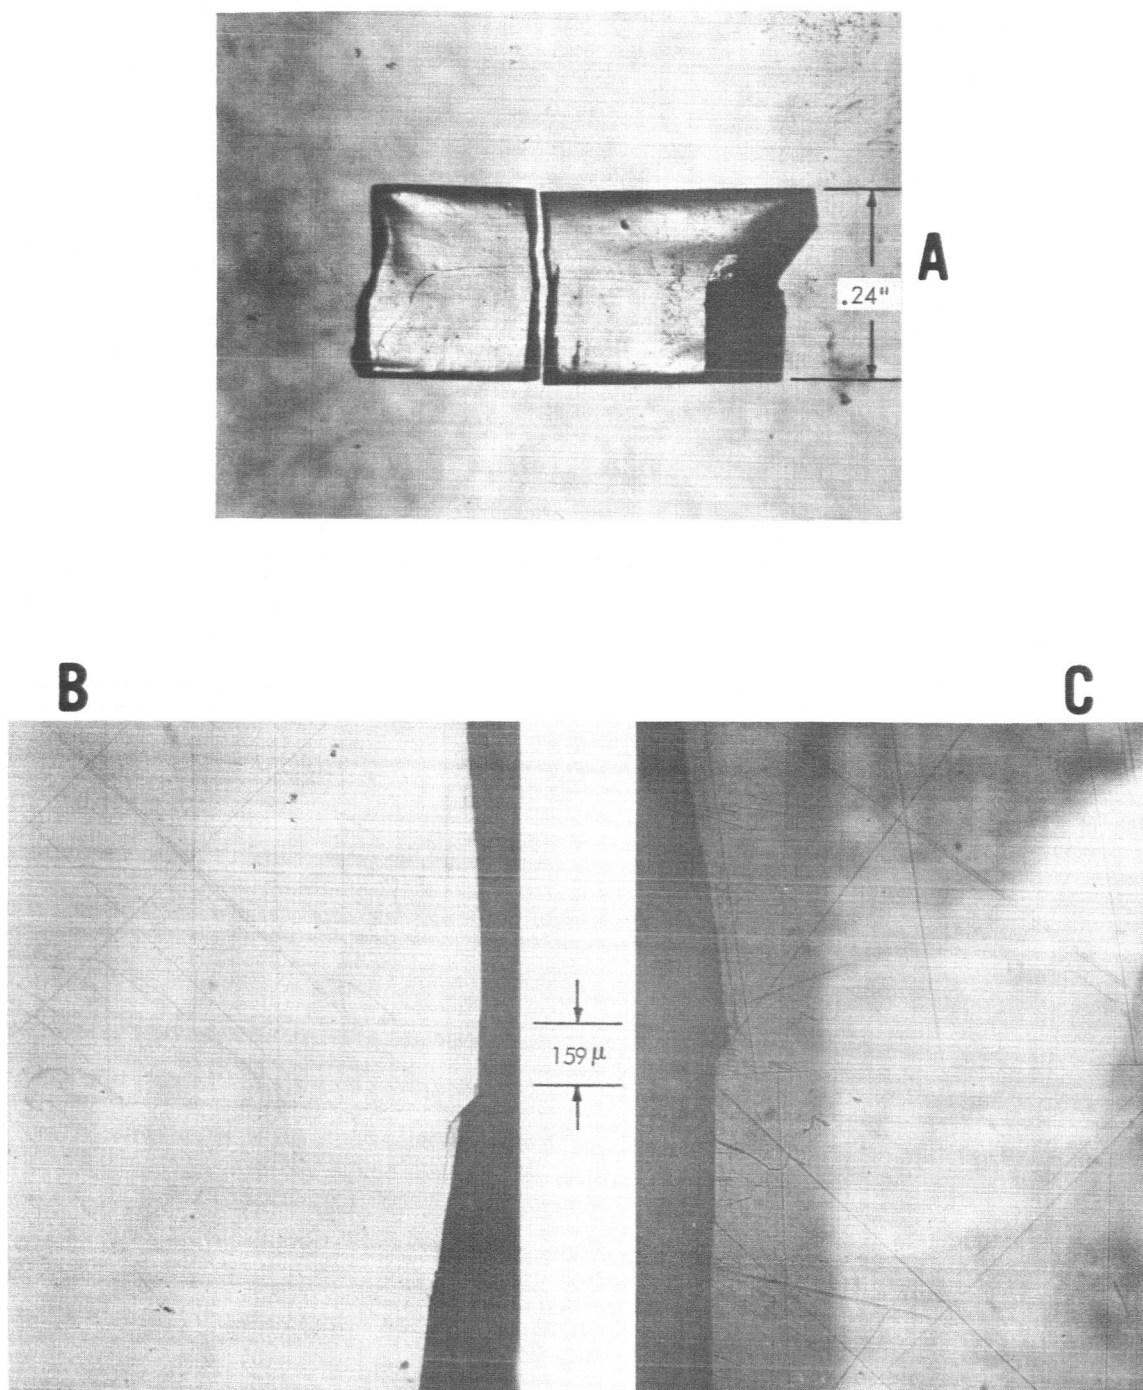
FIGURE 3 - TENSILE SURFACE OF MgO BI-CRYSTAL Mb-3-1 WITH ABOUT 15° TILT PARALLEL TO THE TENSILE AXIS (A) Macro Photo (B) & (C) Micro Photo of Matching Halves (etched-edge bands are diagonal)

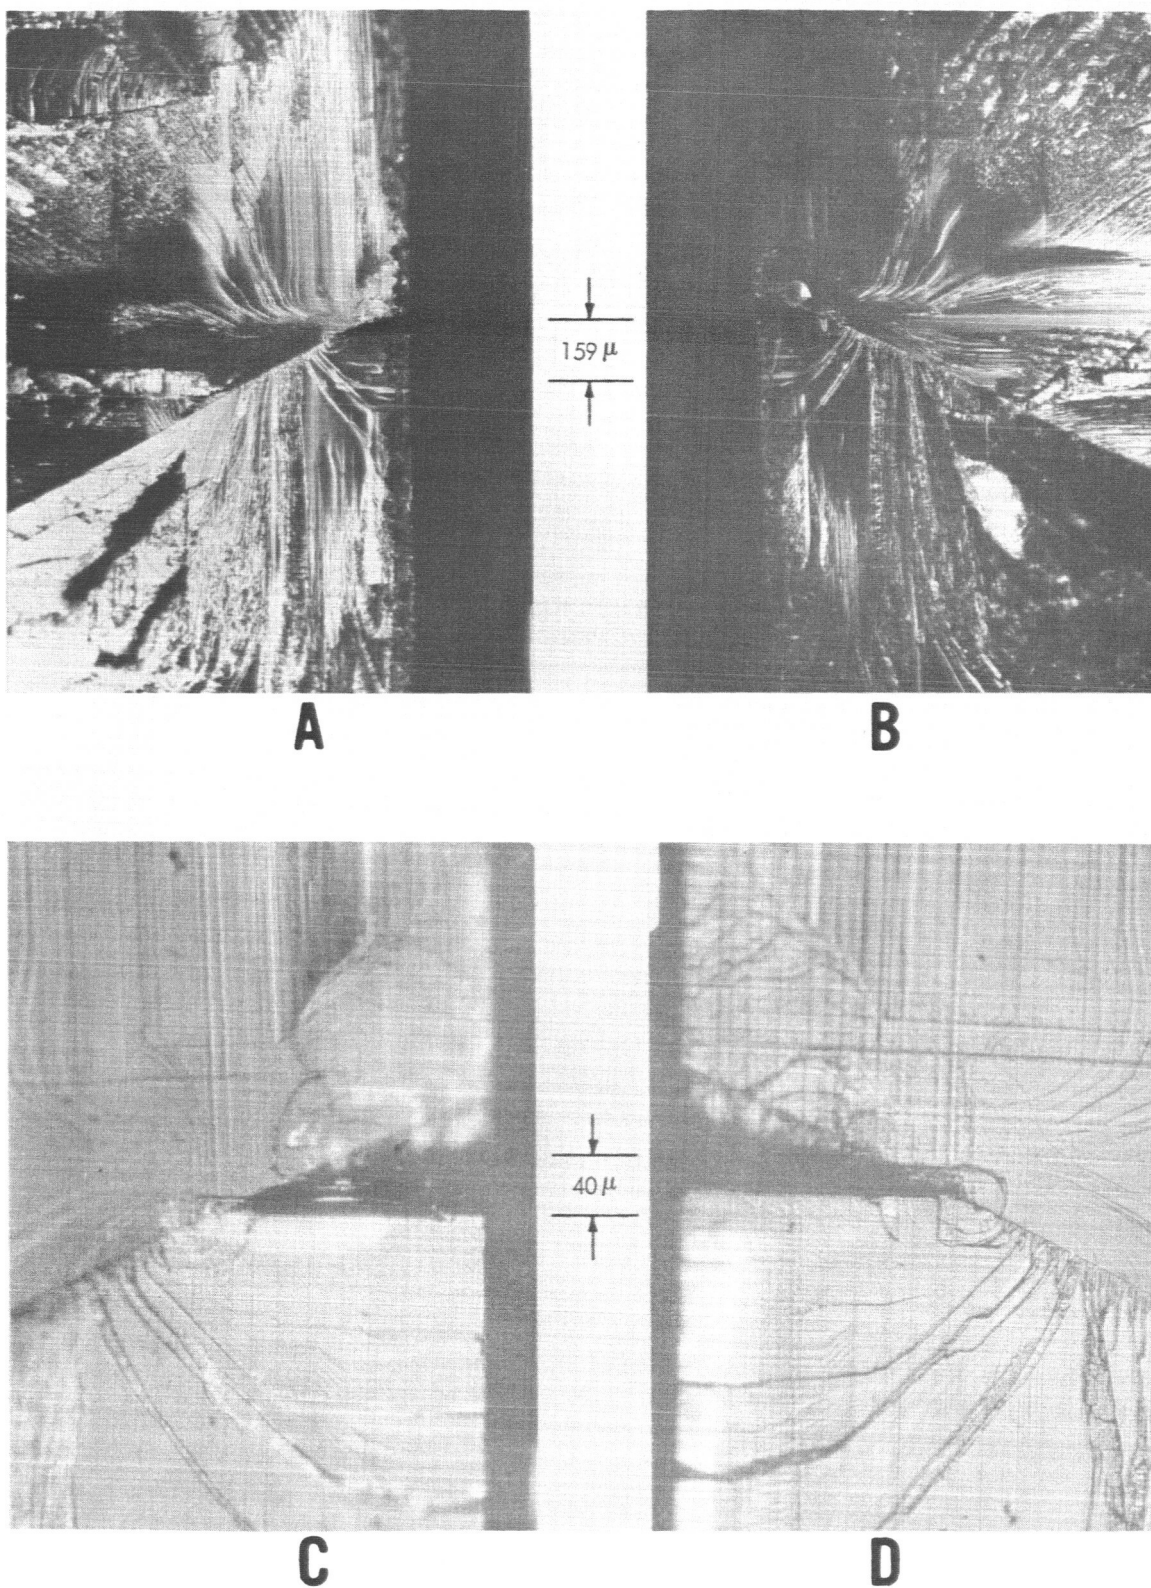
FIGURE 4 - FRACTURE SURFACE OF MgO Bi-CRYSTAL Mb-3-1 (A) & (B) Matching unetched halves, (C) & (D) Matching etched halves
